Breathing new life into a Manhattan landmark

After two of its facades were destroyed in the September 11 attacks, expert stonecarvers have been called in to replicate the intricate stonework at the historic Barclay-Vesey Building in New York City

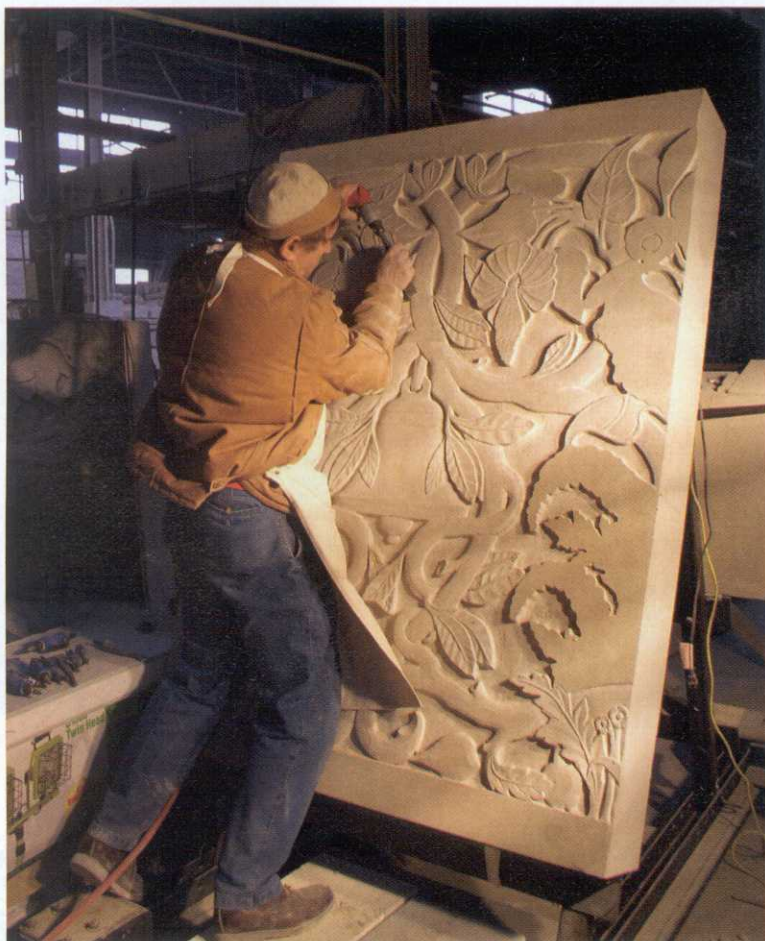
Much of the Barclay-Vesey Building's carved limestone was destroyed during the September 11 terrorist attacks on New York City. The Indiana limestone panels are currently being replicated by artisans such as Bob Carpenter (pictured) at Petrillo Stone Corp. of Mt. Vernon, NY.

To reproduce the original limestone carvings that were destroyed, Tishman Construction, the general contractor, selected Petrillo Stone Corp. of Mt. Vernon, NY. Owners Ralph and Frank Petrillo of Petrillo Stone Corp. explained that their company has had a history of working with Tishman and that its proximity to lower Manhattan made

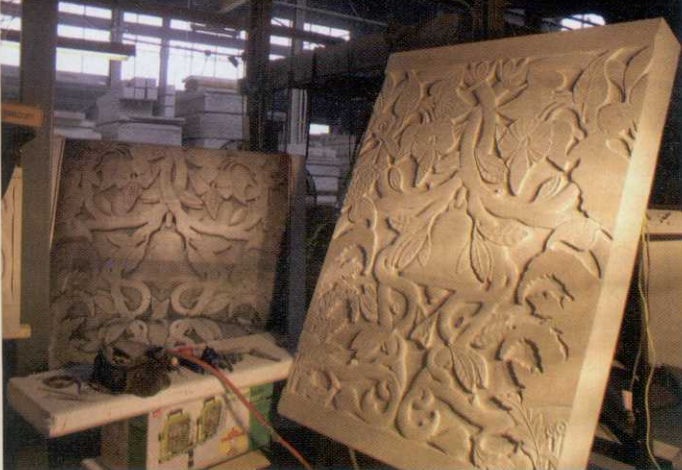
Full-sized photos were taken of the building's stonework for the carvers to reference during the process. The photos were also used to make latex matting that outlines the surface designs of the stonework. This matting is then placed over the slabs so they can be sandblasted in the same way that stone monuments are processed.
